# HYDROMODIFICATION SCREENING FOR QUARRY CREEK

(C.T. 11-04)

October 3, 2012

**ChangConsultants**  
Civil Engineering • Hydrology • Hydraulics • Sedimentation

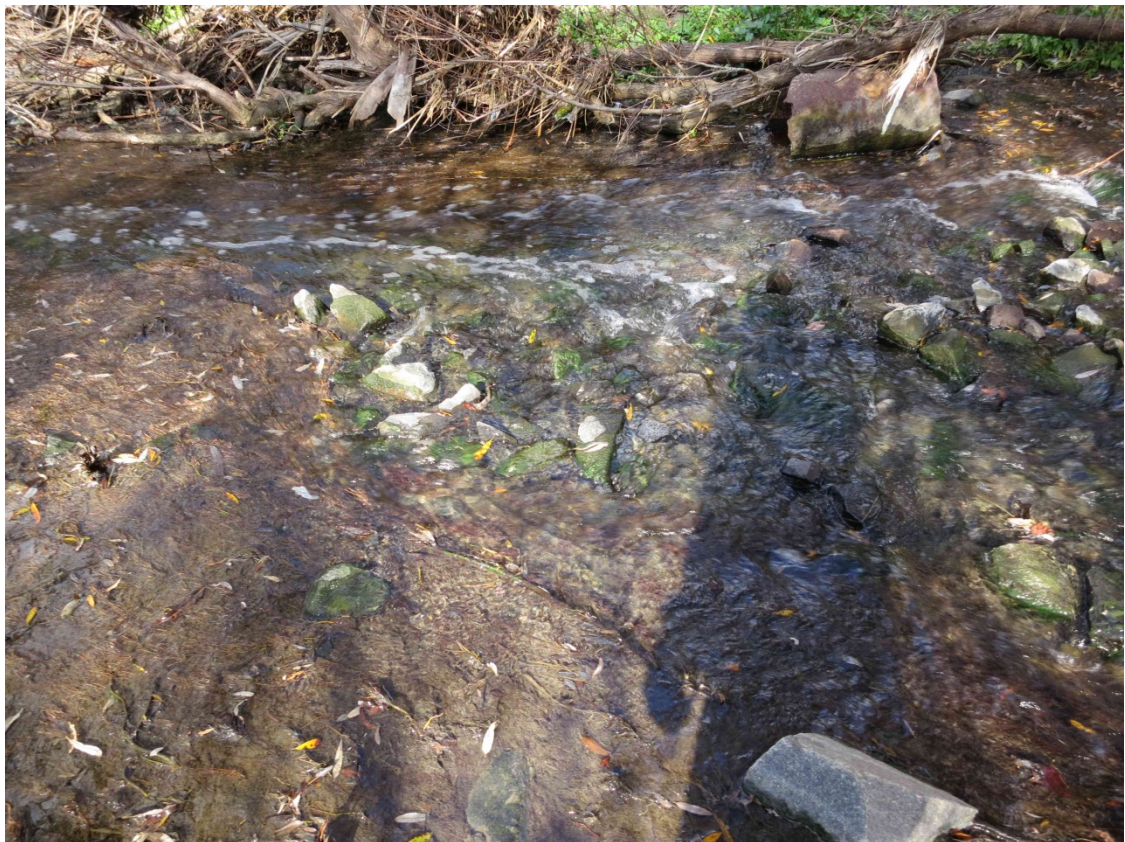
**Figure 6. Rocks and Gravel in Buena Vista Creek Channel Bed Downstream of Hanson Channel**

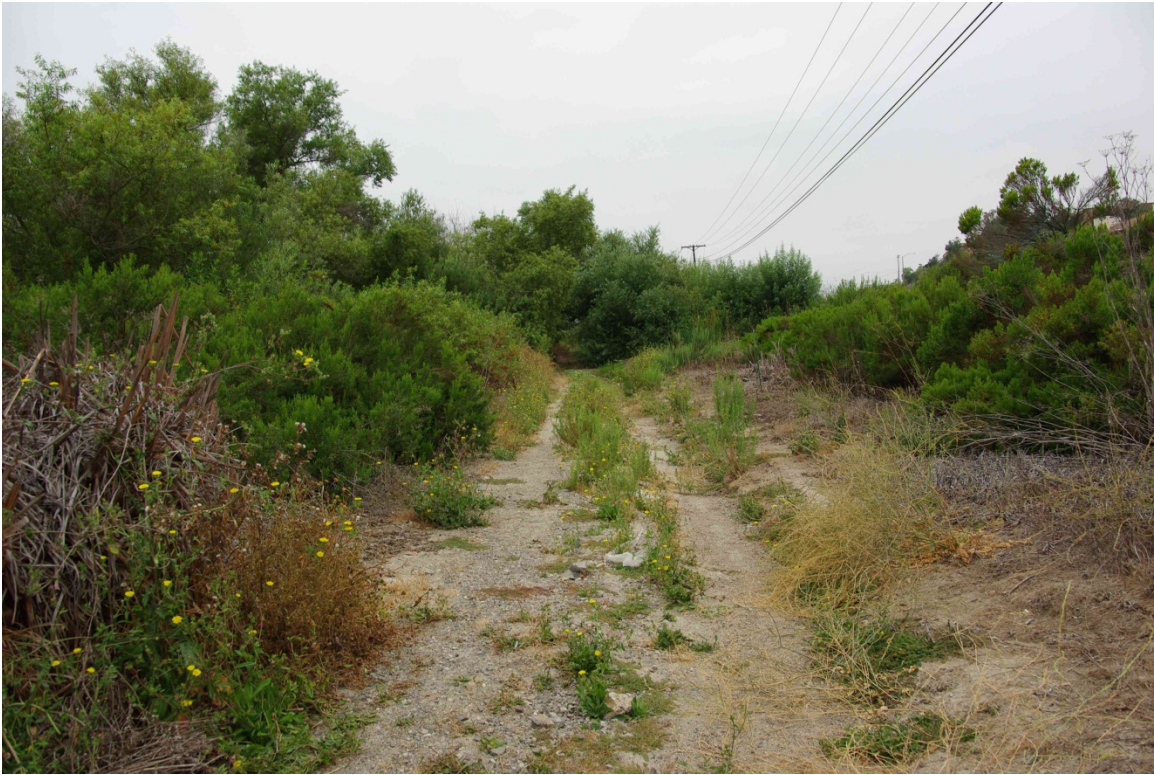
**Figure 7. Dense Vegetation at Edge of Buena Vista Creek Adjacent to Access Road**

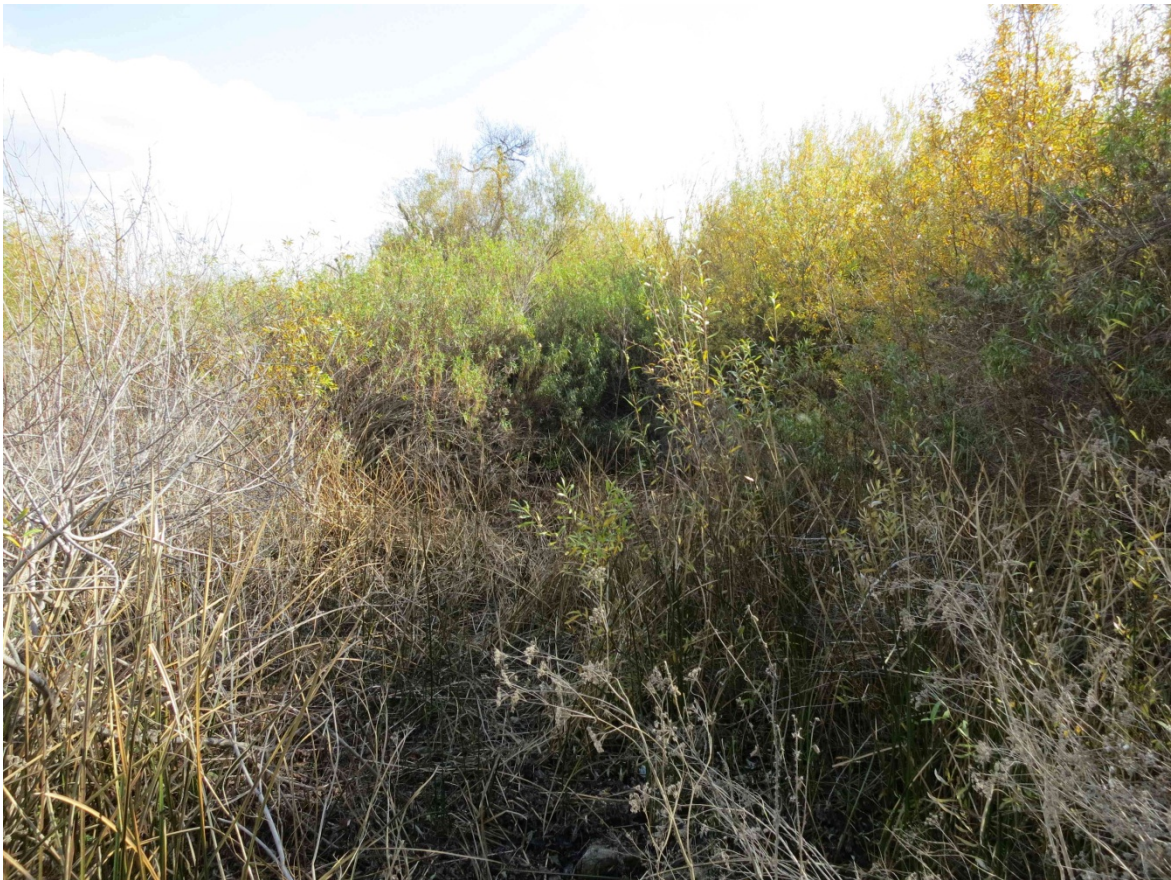
**Figure 8. Dense Vegetation in Buena Vista Creek Looking Upstream from East End of Westerly Segment of Haymar Drive**

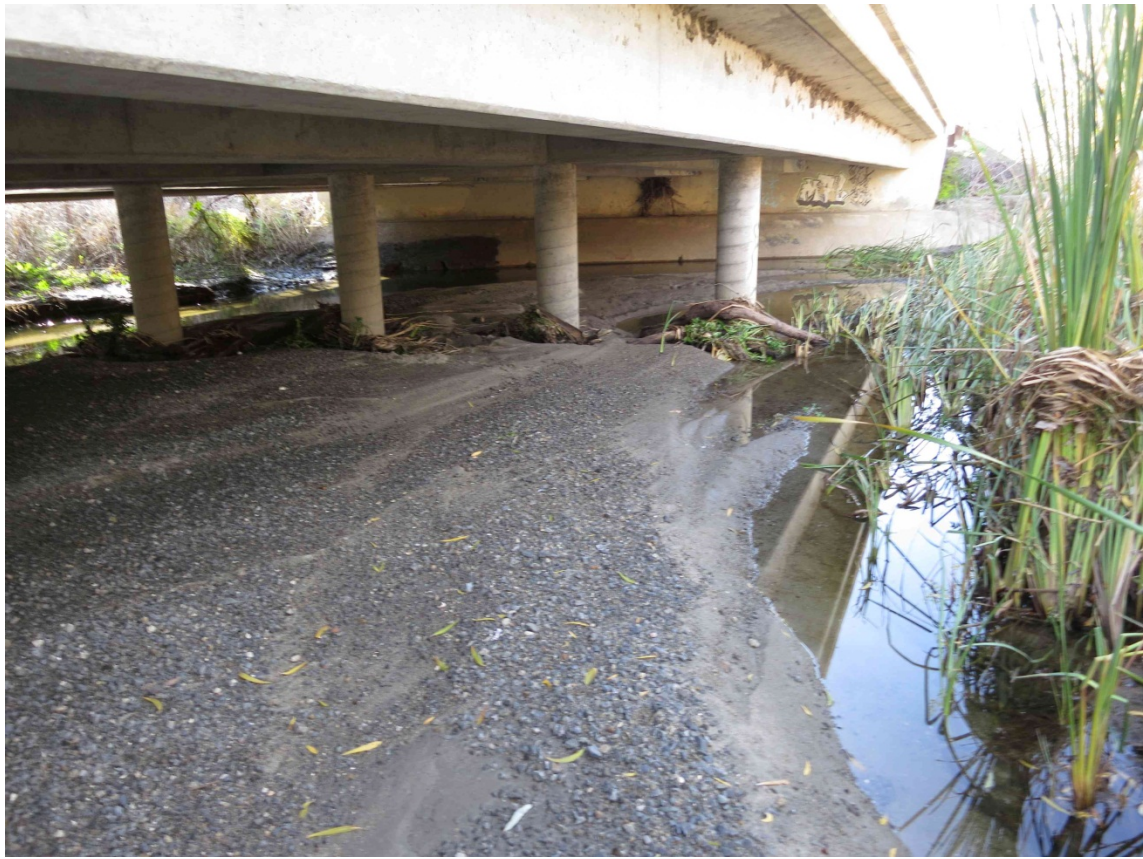
**Figure 11. Gravel Bed under Haymar Drive Bridge over Buena Vista Creek**

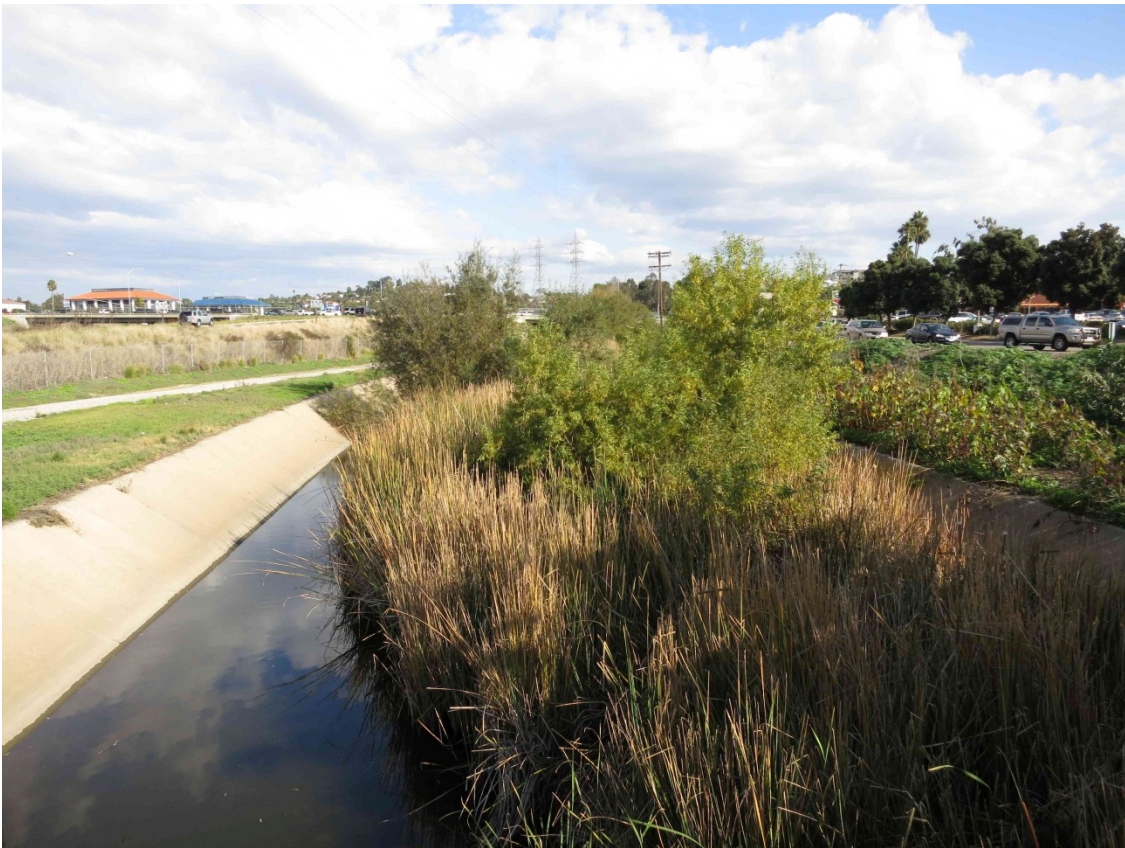
project. For POC 1 and 2, a drop structure exists within 70 feet. For POC 3, 4, and 5 the first permanent grade control is a concrete-lined trapezoidal channel approximately 250 feet upstream of El Camino Real (see Study Area Exhibit).

**Figure 13. Concrete-Lined Trapezoidal Channel near El Camino Real (vegetation growth on concrete)**

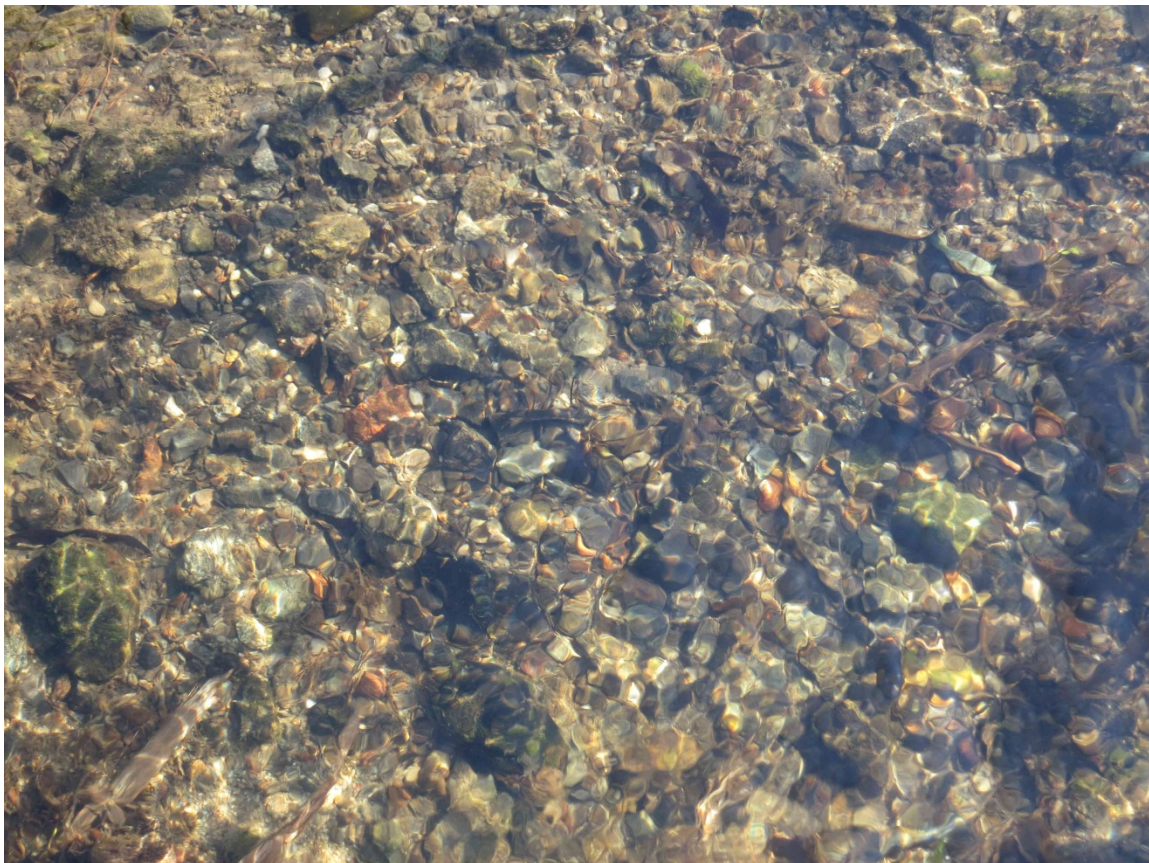
**Figure 14. Gravel on Buena Vista Creek Channel Bed near El Camino Real**

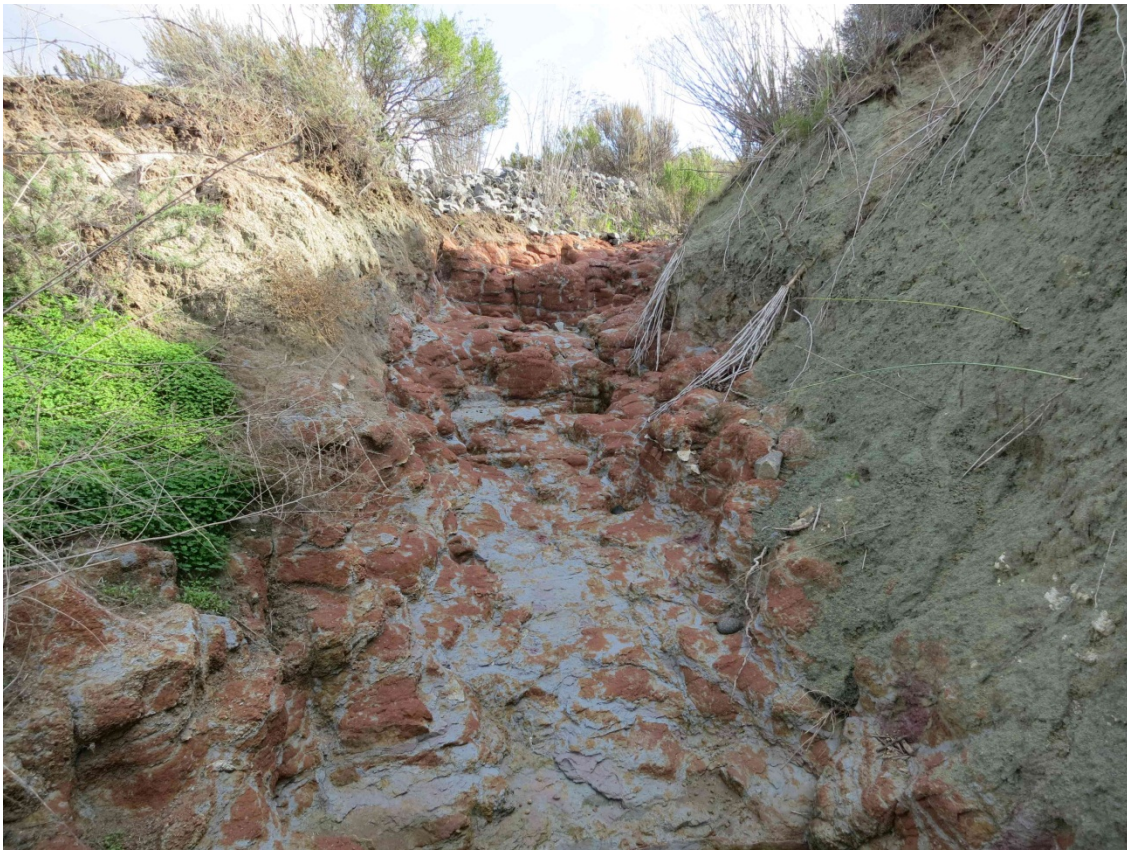
**Figure 15. Bedrock at Upper End of Middle Tributary**

Checklist 2 determines grade control characteristics of the channel bed. This is based on the spacing of the grade controls. Reach 6 below POC 1 and POC 2 encompasses the Hanson channel, which contains multiple grade controls (see Figures 1 through 4), so this area falls within Category A on Checklist 2. Portions of Reach 7 have eroded to bedrock (see Figures 15

and 16), so this area also falls within Category A on Checklist 2. In all of these reaches, the grade control spacing meets the threshold in Category A.

The first step in the decision tree is to determine if lateral adjustments are occurring. The adjustments can take the form of extensive mass wasting (greater than 50 percent of the banks are exhibiting planar, slab, or rotational failures and/or scalloping, undermining, and/or tension cracks). The adjustments can also involve extensive fluvial erosion (significant and frequent bank cuts on over 50 percent of the banks). The banks are intact in the photographs included in the figures. The relatively uniform, dense vegetative cover on many of the banks is evidence of the absence of large lateral adjustments. Neither lateral mass wasting nor extensive lateral fluvial erosion was evident within any of the reaches during a field investigation. Reach 7 was the only portion of the entire study area that exhibited bank erosion. However, the erosion is not associated with lateral changes, but with historic vertical changes. The bottom of Reach 7 has reached bedrock, so future vertical changes will be limited.

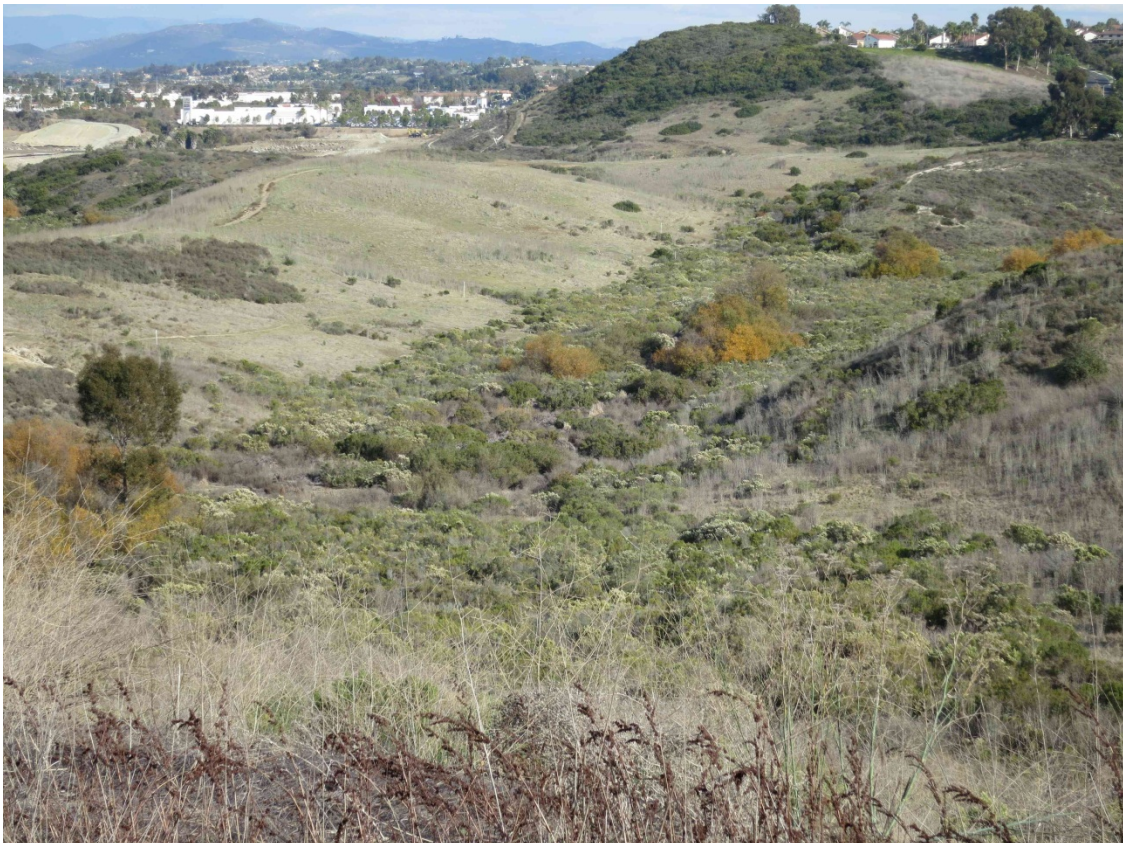
**Figure 18. Looking Upstream along Densely Vegetated West Tributary**

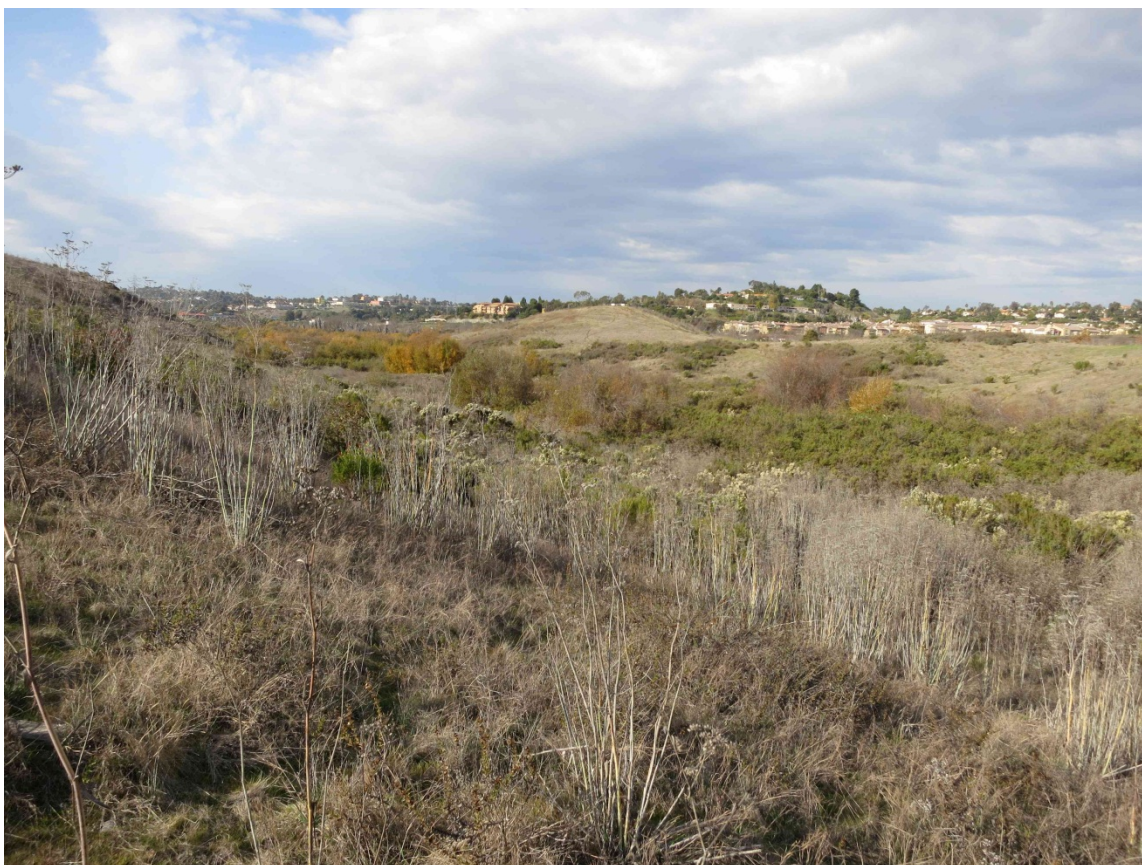
**Figure 19. Looking Downstream along Densely Vegetated West Tributary**

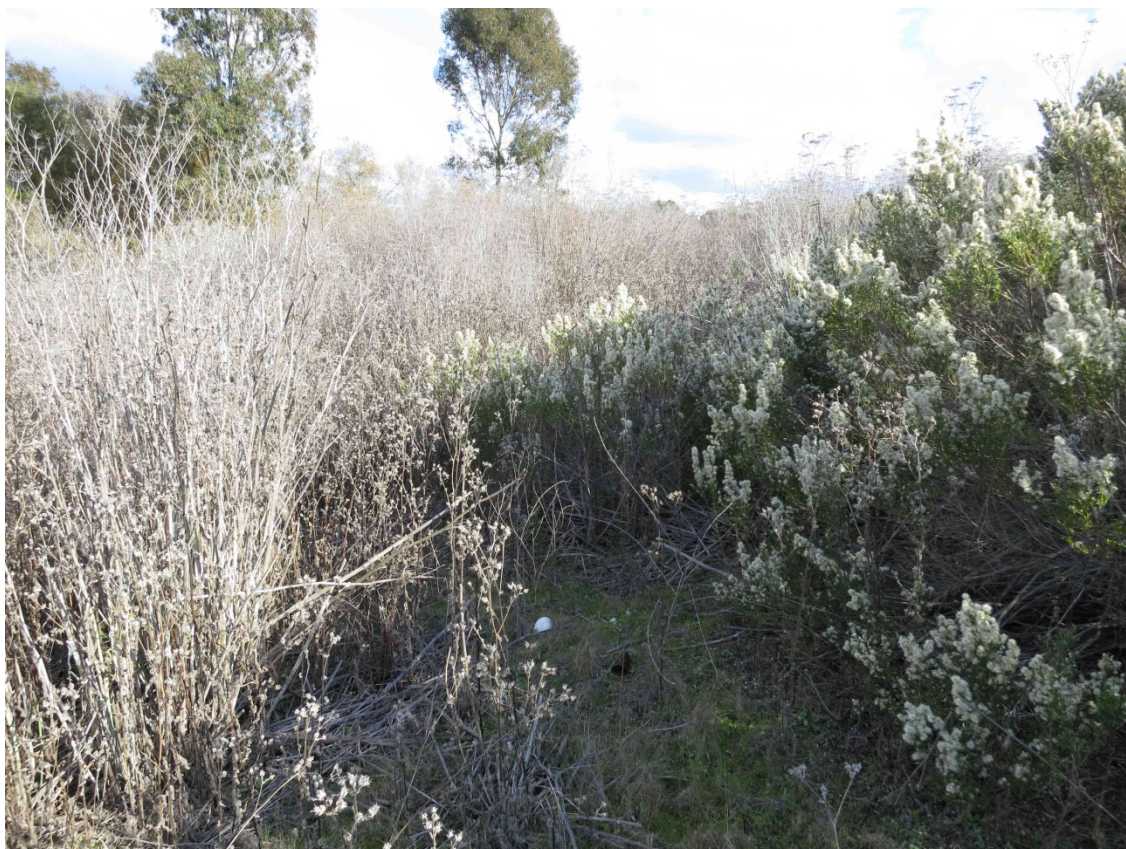
**Figure 20. Vegetation within West Tributary Floodplain**

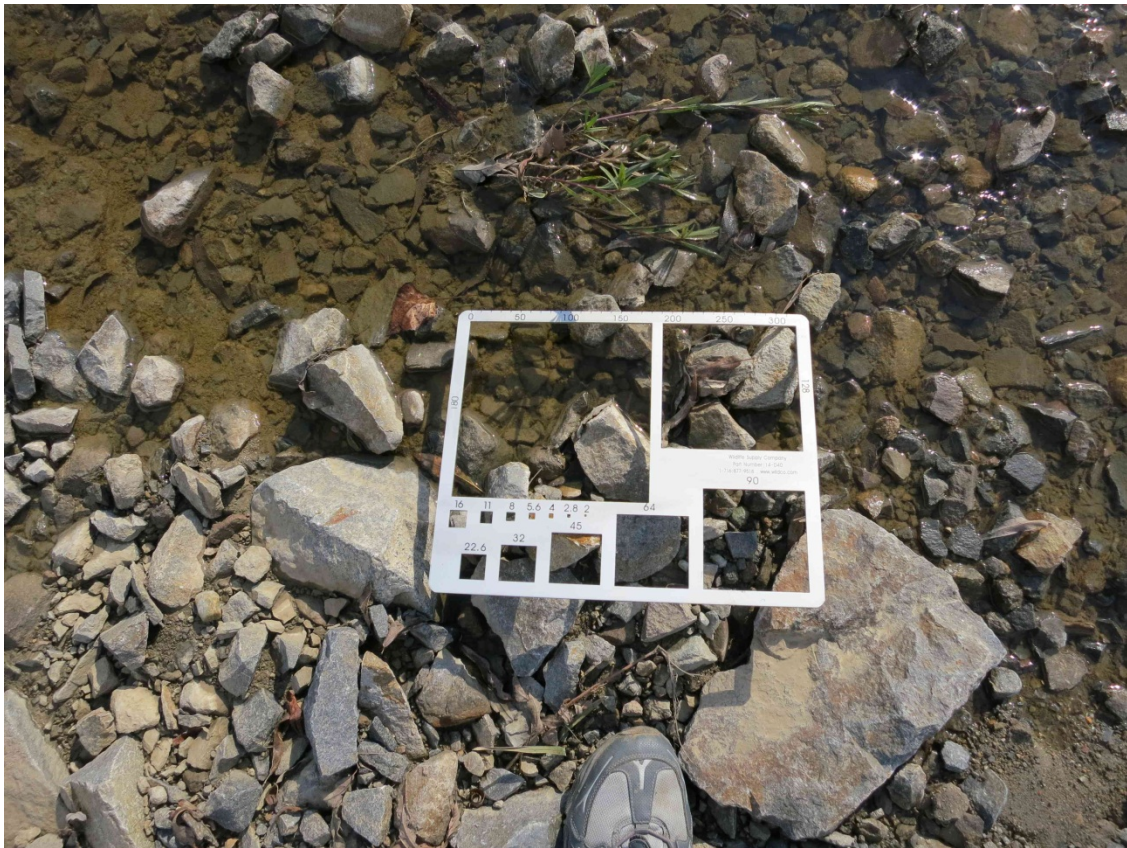
**Figure 21. Channel Bed Material within Hanson Channel of Buena Vista Creek**

Figures 21 through 27 show photographs of the bed material within Buena Vista Creek, the Middle Tributary, and the West Tributary. A gravelometer is included in the photographs for reference. Each square on the gravelometer indicates grain size in millimeters (the squares range from 2 mm to 180 mm). Based on the photographs and site investigation, the bed material and resistance is generally within the transitional/intermediate bed category. There was no evidence of a threshold bed condition. The figures show that the grain size is fairly large in the upstream reach of Buena Vista Creek and decreases in the downstream direction. Even the smaller grain sizes are rather gravelly. In the Middle Tributary, the grain size is typically in the gravel range. In the West Tributary, there are gravel sized particles, but a larger population of smaller grain sizes.
